INVESTIGATION OF THERMAL FATIGUE IN
NON-TUBULAR REGENERATIVELY COOLED
THRUST CHAMBERS. VOLUME II

AFRPL-TR-73-10
VOLUME II

FINAL REPORT
VOLUME II

ROCKETDYNE DIVISION, ROCKWELL INTERNATIONAL
6633 Canoga Avenue, Canoga Park, California

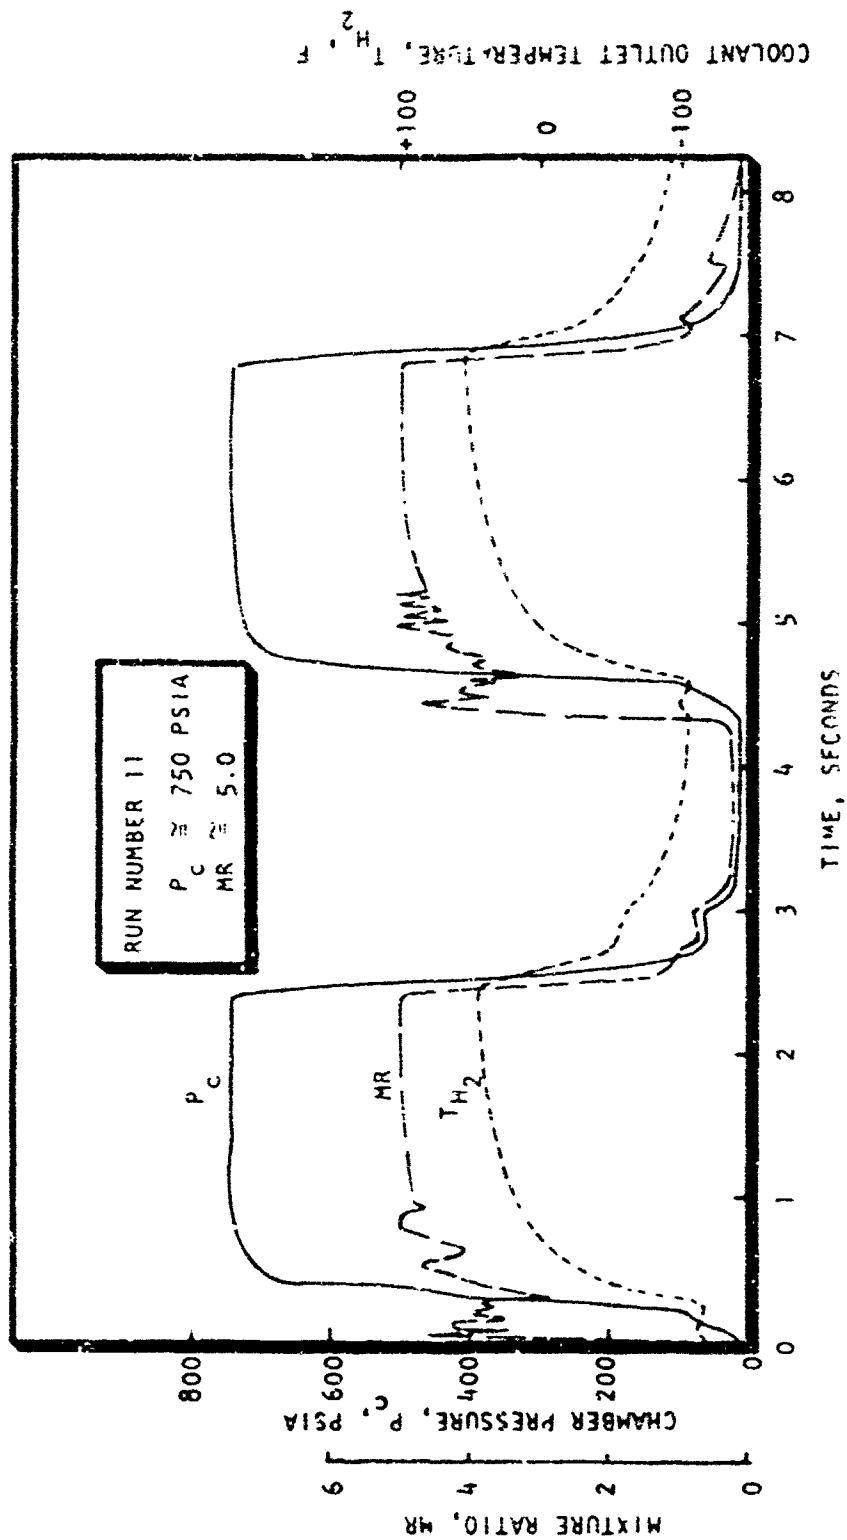
Figure 62. Typical Thermal Fatigue Chamber Test (Run No. 11)

Typical measured test data are shown in Fig. 62 and 63 for run number 11 which was at approximately 750 psia chamber pressure and a mixture ratio of approximately 5.0. To match the measured transient backwall temperature profiles, coolant bulk temperature versus time was determined at the desired location and the predicted coolant-side film coefficient was corrected for the coolant temperature and the measured coolant flowrate. Then the gas-side coefficient was varied until a reasonable correlation with the measured backwall temperature was achieved. Predicted wall temperature transients for three axial locations are presented in Fig. 64 through 66. The maximum thermal gradient (gas-side to back-wall) occurred at approximately 0.15 second into the cycle.

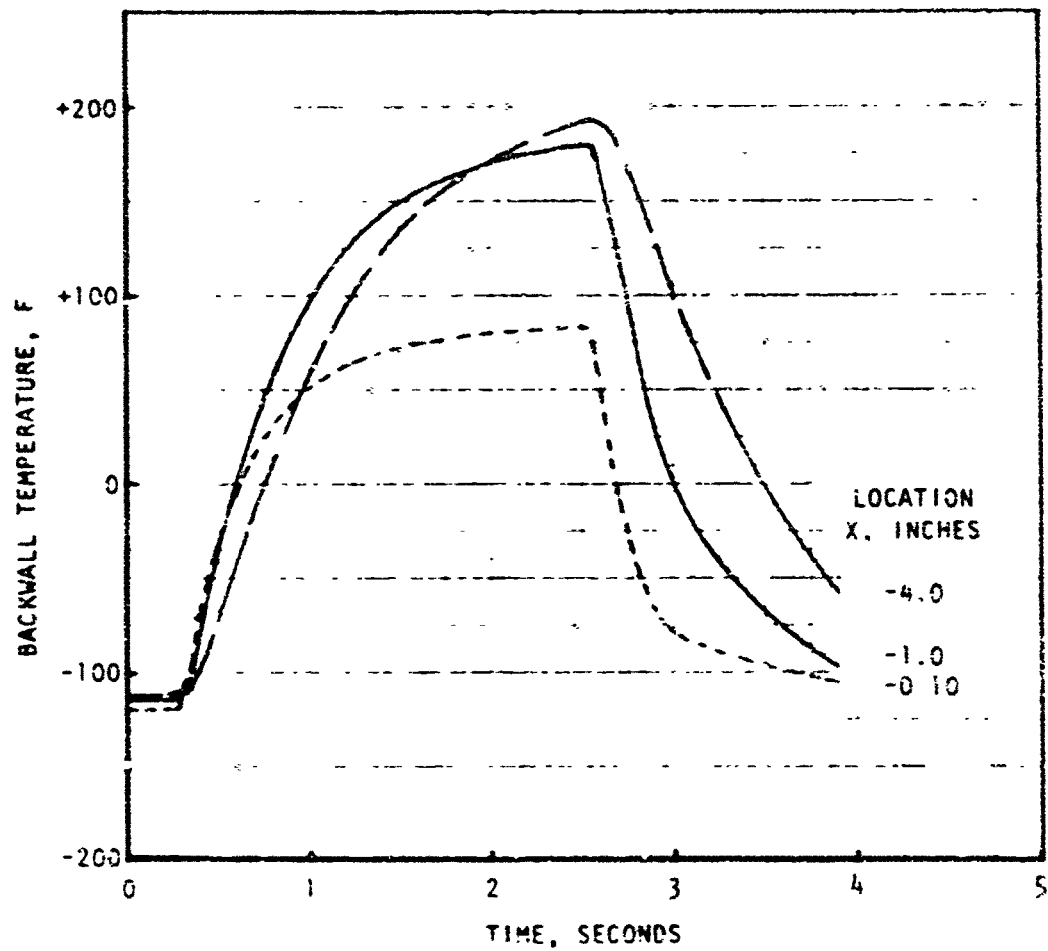
Figure 63. Typical Measured Backwall Temperatures
(Run No. 11)

Fairly good agreement were obtained for the start to the steady-state portion of the cycle; however, for the shutdown the predicted temperature did not decay as rapidly as the measured value for the $X = -1.0$ inch and -0.1 inch locations. ($X = 0$ is throat plane and $-X$ indicates distance upstream of the throat). This may be the result of some axial heat conduction occurring through the backwall on shutdown. Typical wall temperature distributions at various times in the cycle are shown in Fig. 67 through 69.

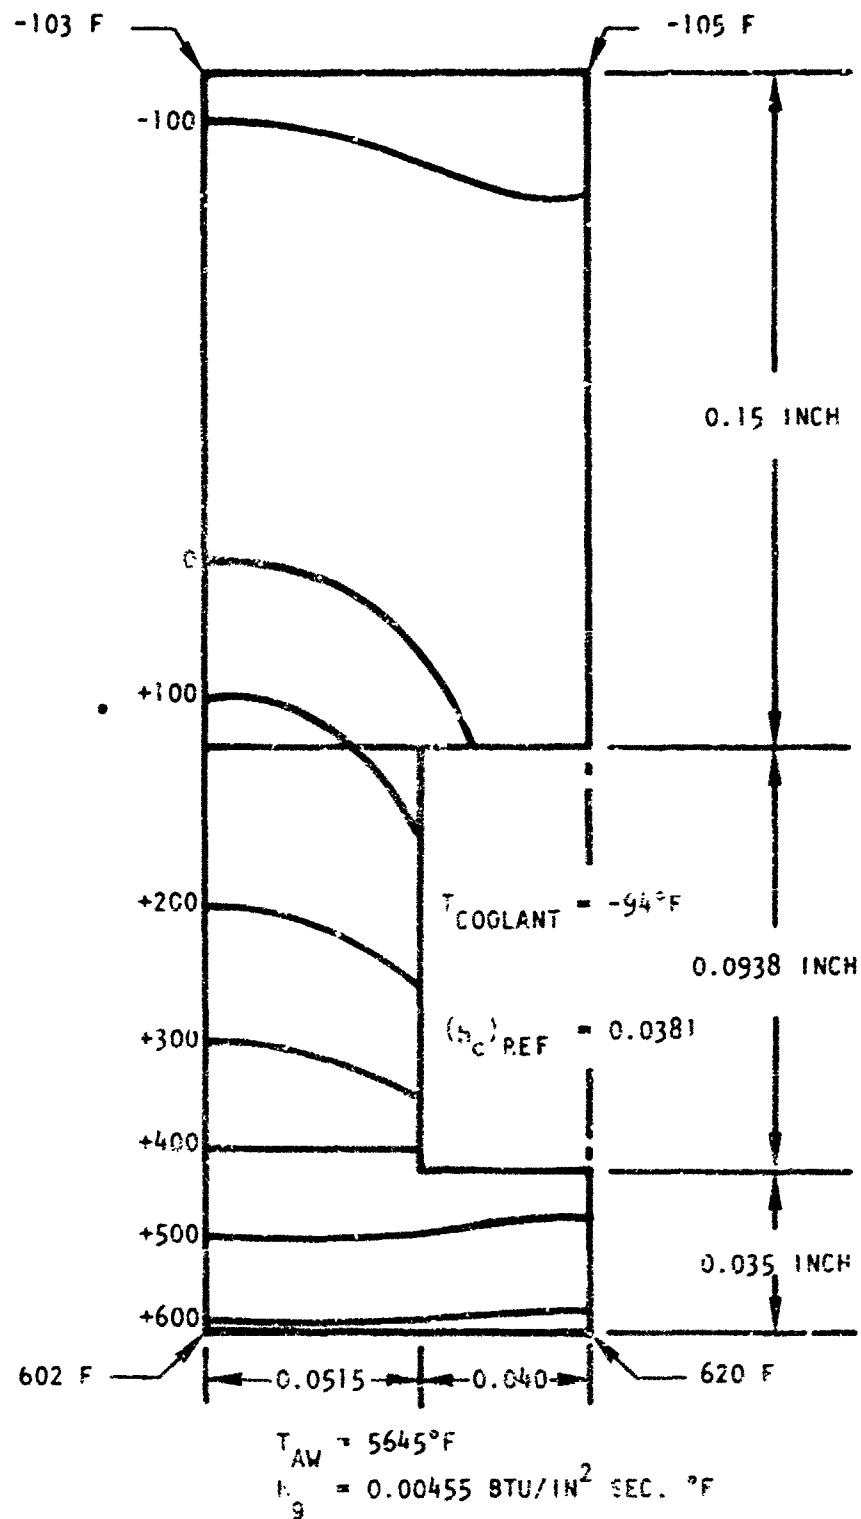
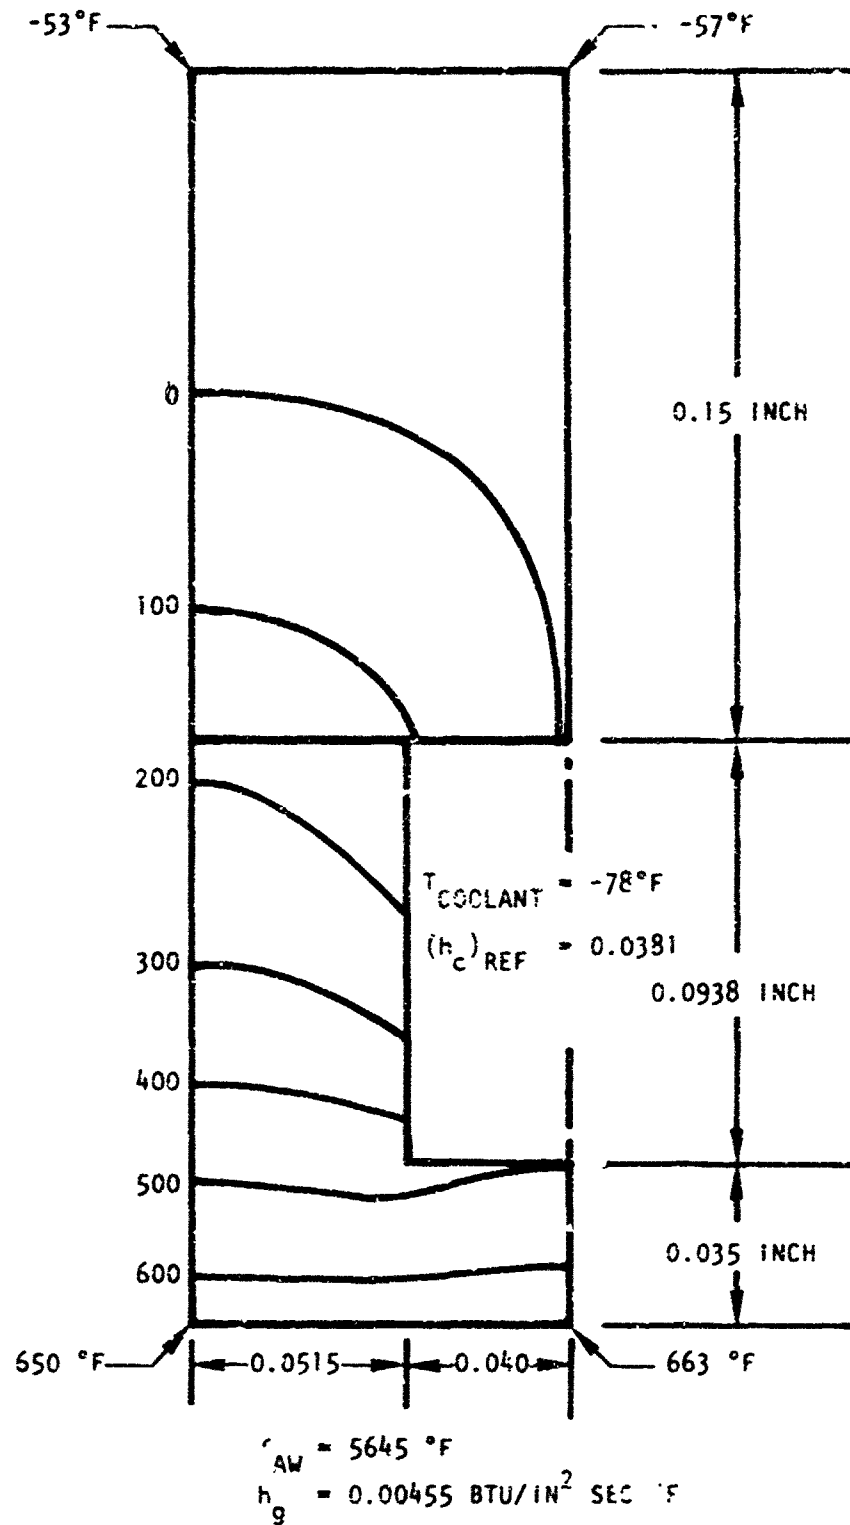
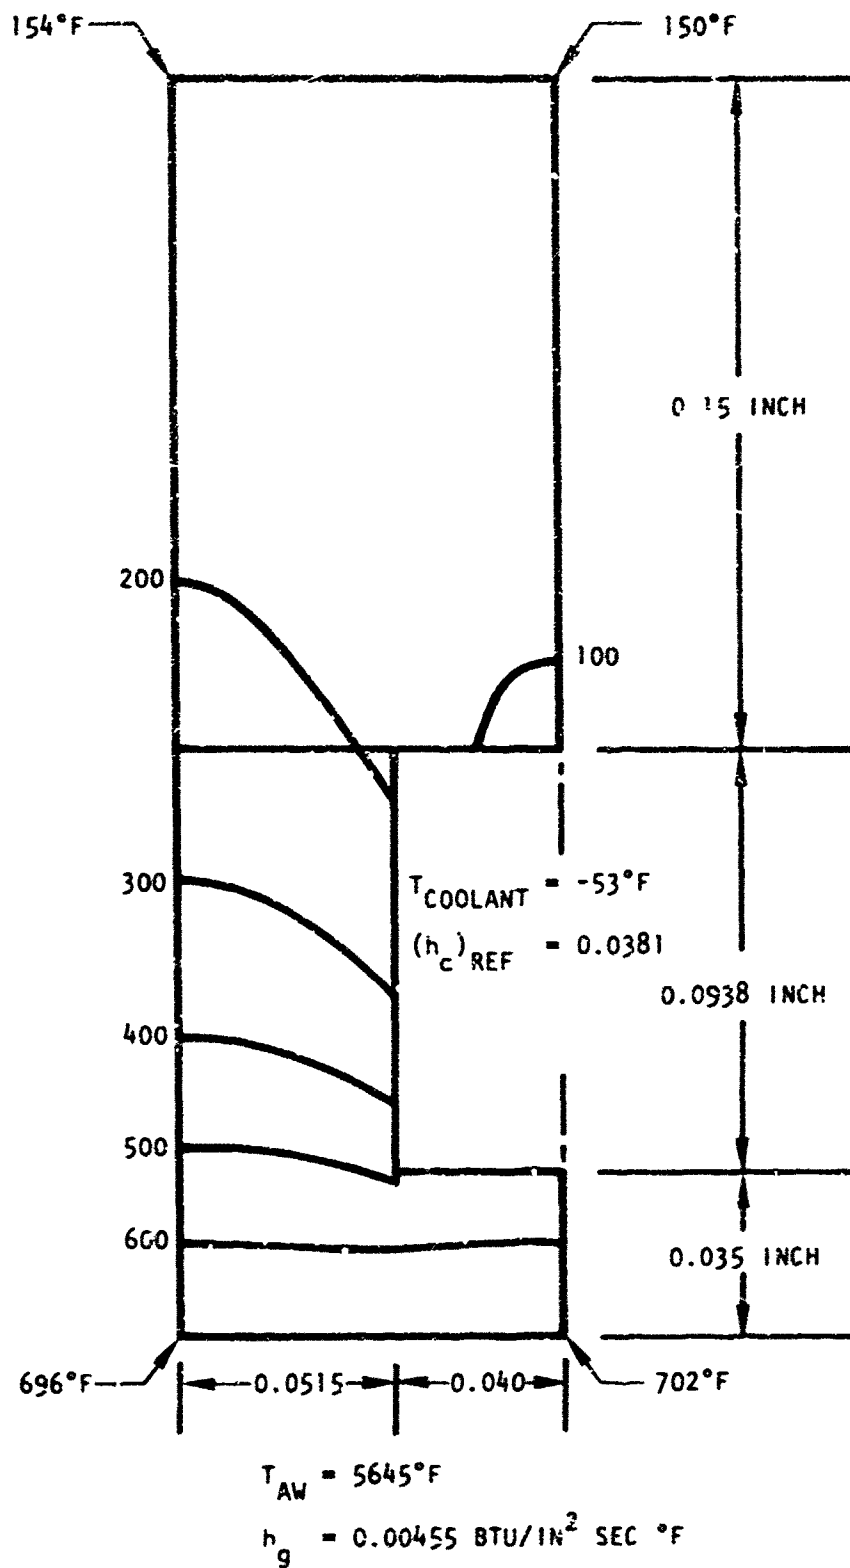
Figure 67. Thermal Fatigue Chamber Wall Temperature Distribution at $X = -1.0$ inches and $t = 0.15$ second (Run No. 11)

Figure 68. Thermal Fatigue Chamber Wall Temperature Distribution at $X = -1.0$ inches and $t = 0.3$ second (Run No. 11)

Figure 69. Thermal Fatigue Chamber Wall Temperature Distribution at $X = -1.0$ inches and $t = 1.35$ seconds (Run No. 11)

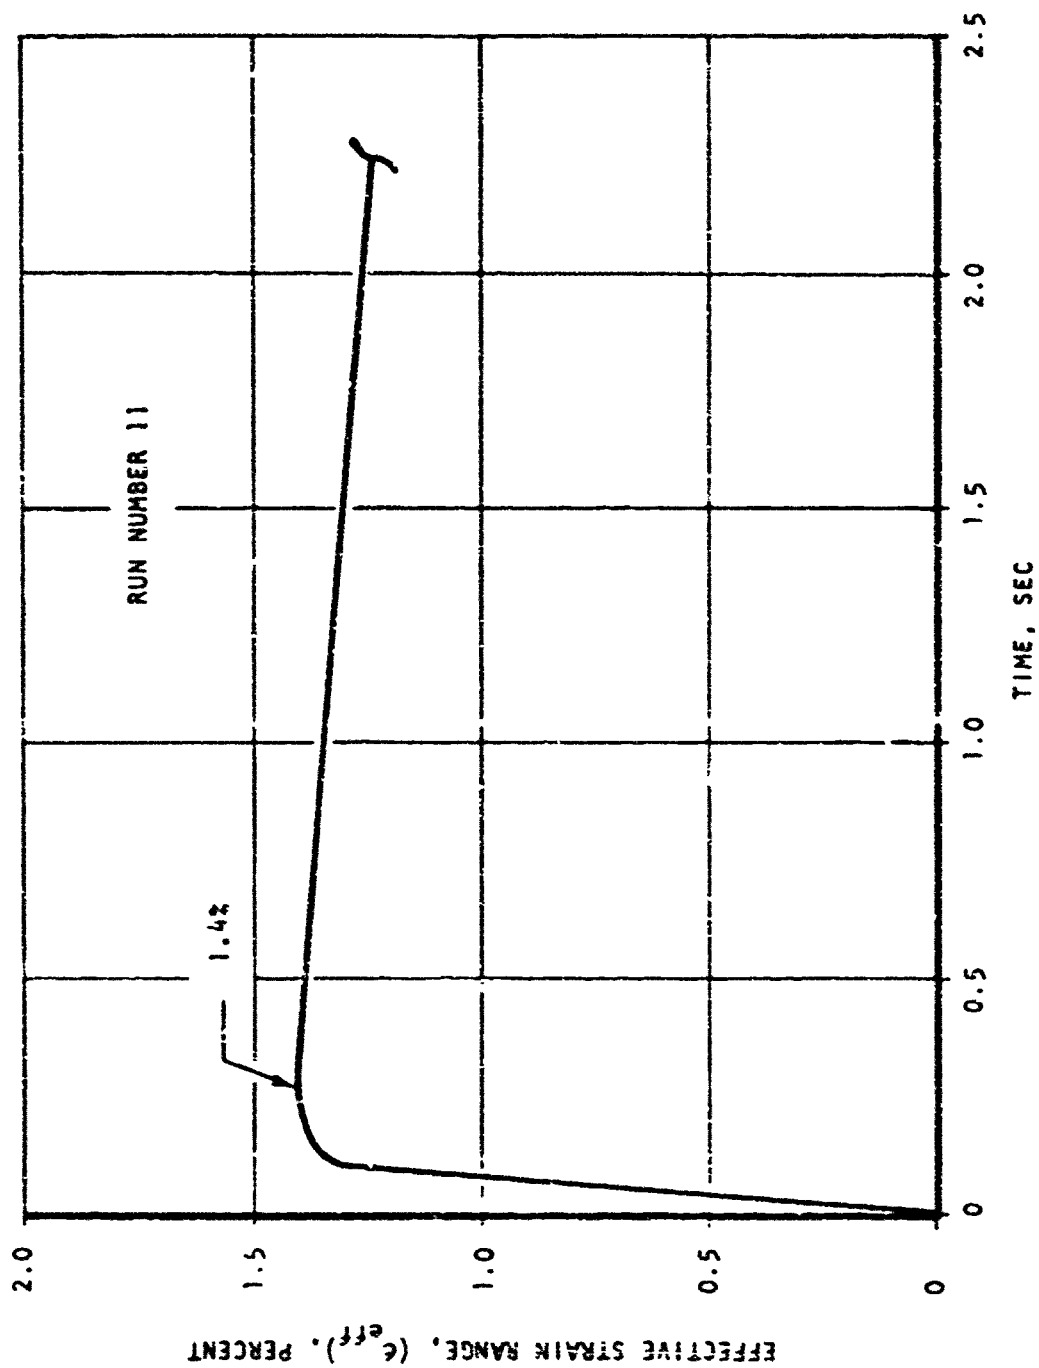
Figure 70. Effective Strain on Hot Gas Wall of NARloy-Z Chamber

From these thermal data an analysis was undertaken to determine the maximum effective strain imposed on the hot gas wall during the start cycle. Results, plotted in Fig. 70 showed that a peak strain of ~ 1.4 percent occurred at a point 1.0 inches upstream of the throat and at a time 0.3 seconds into the run. Steady state strain value at the same plane is ~ 1.25 percent. The strain is higher during the start transient than at steady state conditions since the hot gas wall responds much faster than the back wall, resulting in a greater temperature differential across the chamber wall during the transient.

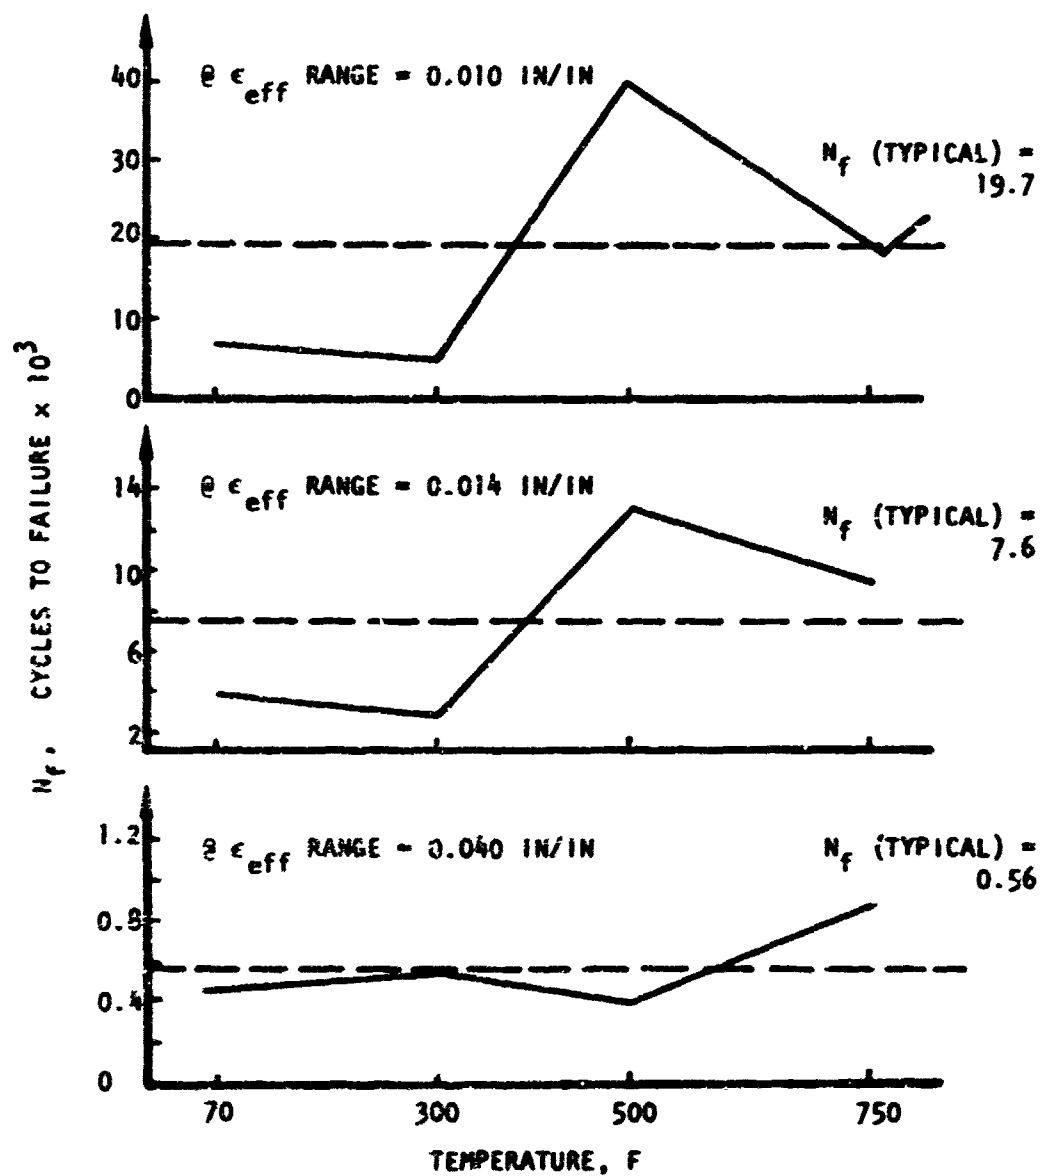
Figure 71. Cycles to Failure vs Temperature at Constant Effective Strain Range

In parallel with this, the isothermal fatigue data reported in Volume I was cross plotted to determine cycles to failure capability versus temperatures for several effective strain ranges as shown in Fig. 71. These data were then used to determine cycles to failure versus effective strain for the incrementally averaged data. Results are shown in Fig. 72. Also, upper and lower bounds were established based on the data scatter resulting from the isothermal fatigue tests. These data are for heat D5402, the heat of NARloy-Z used in the isothermal fatigue testing. These data were then adjusted for heat D5415, (the ingot used to make the thrust chamber) by the differences in basic material properties; accomplished by using the Universal Slopes equation as discussed in Volume I. These results, presented in Fig. 73 result in a plot of cycles to failure versus effective strain for the NARloy-Z chamber that was cyclic tested. Entering this curve at 1.4 percent effective strain shows a predicted life for the NARloy-Z chamber of 3100 to 15,000 cycles. These values are indicative of the cyclic life capability of a NARloy-Z chamber which has no inclusions as was experienced on the hardware listed here.
